15/03/2021

HEAVY VEHICLE RESTING AND STOPPING AREAS ON E18

Observation in Turku - Vaalimaa corridor

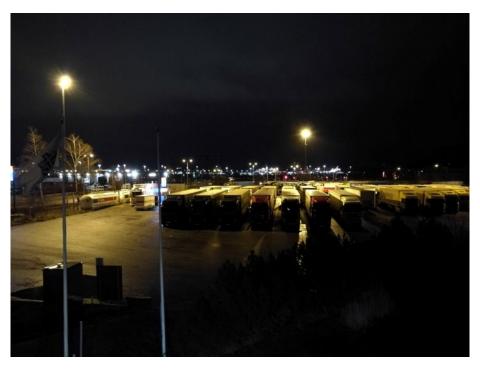
Picture 1. Parking area near Turku Seamen Church for heavy equipment.

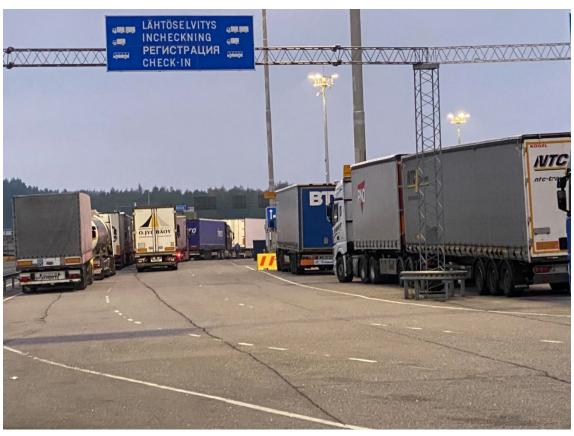
Picture 3. Heavy traffic vehicles queuing at the Turku harbor check-in.

Based on our own observations and the very uniform feedback from drivers, Viking Line's Turku port is going very smoothly when vehicles have arrived in the loading area; however, the length of the lane received some feedback on its small size. Road works in the harbor area cause congestion both when entering the port, and especially when exiting. Cars get out of the ship in line and especially for drivers, for whom the harbor area is not familiar, there may be great challenges in finding a way out. However, the problem is temporary and should go away once the road works are

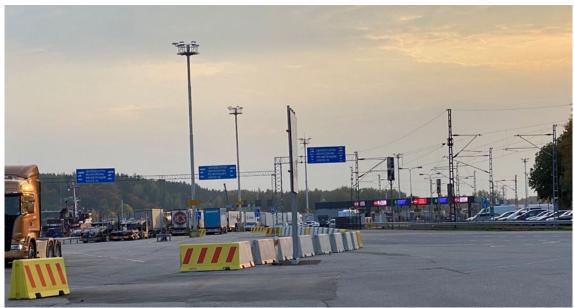
Picture 6. Evening ship queues

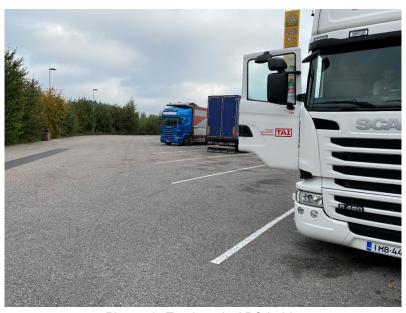
To get to the parking space, you have to drive three 90 degree turns, the time for this driving brought you about 5 minutes and about 2 more miles of travel. Professional drivers get to the break point with the HTC combination. There were 15 tracks for heavy traffic parking spaces. HTC without gridlock can be well accessed. Not guarded. Marks-intangible places are also parked very often.

Picture 9. Truck park, ABC Lohja.

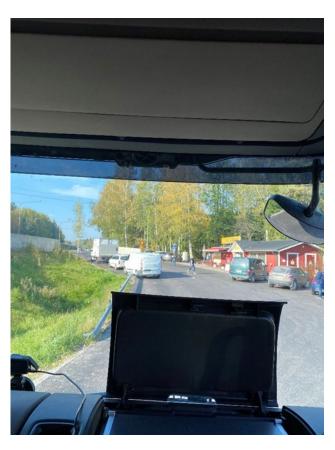
Arriving in the Kulta grilli yard is really easy. The yard is practically closed on the E18 motorway, which makes entering and exiting infinitely easy. The yard is very small. There are no clear parking markings in the yard.

The yard can accommodate about a few full-backs and several half-backs depending entirely on how others have driven into the yard. When you drive to the yard, you must think about where to park so that the others can still get away. At certain times like coffee time and lunchtime the yard is pretty full. With a combination of HCT, you can get to drive well and exit at that break point, but it all depends on how much other cars are in the yard. The stop takes about a minute of the time away.

Picture 10. Kulta grilli parking space.

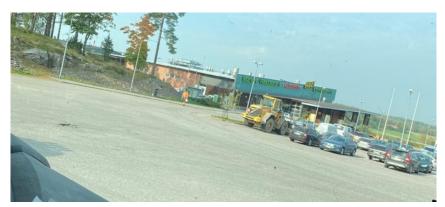
Break room for charters, sauna, no overnight stay, really lots of parking space, easy to get to, yard a bit bumpy.

Truck driver comment: "Evening parking space completely blocked, shower is most often untidy, nice plus would be that on the side of the big road there would be the number of free heavy equipment parking spaces for digital display."

Picture 12. ABC Loviisa parking space.

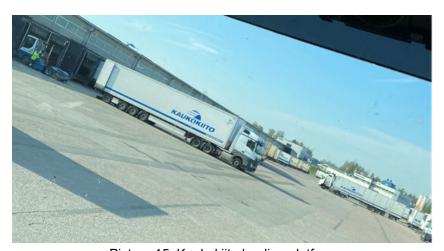
The exit from the E18 road was effortless, but the journey to the terminal was a bit long. When we arrive at Vantaa we find it to be a large terminal. The courtyard is fenced through and passage in and out occurs from gates with camera surveillance. So you can't get in without ending up in surveillance. In addition to the terminal itself, at the back we see storage hangars, which also have piers and an outdoor platform for long goods. I'm sure there are at least a hundred pieces of piers with a quick glance. The yard looks easy to operate with any combination. You can straighten the front of the piers even with a long combination, even if the adjacent platforms are reserved. You can drive around the yard, and you have enough space if you must make the combinations and vary.

Picture 15. Kaukokiito loading platform.
