15/03/2021

HEAVY VEHICLE RESTING AND STOPPING AREAS ON E18

Observation in Turku - Vaalimaa corridor

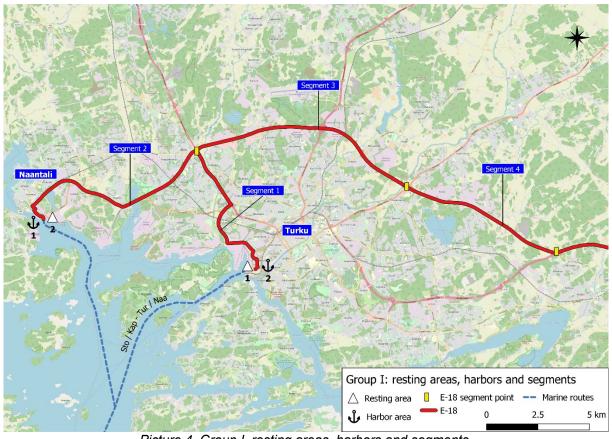
Picture 4. Group I, resting areas, harbors and segments.

Segment 3. In the closing stages of the segment, roundabouts caused a rubber band effect when there were many heavy vehicles in a row. Due to the sites, driving lanes were cramped at some points.

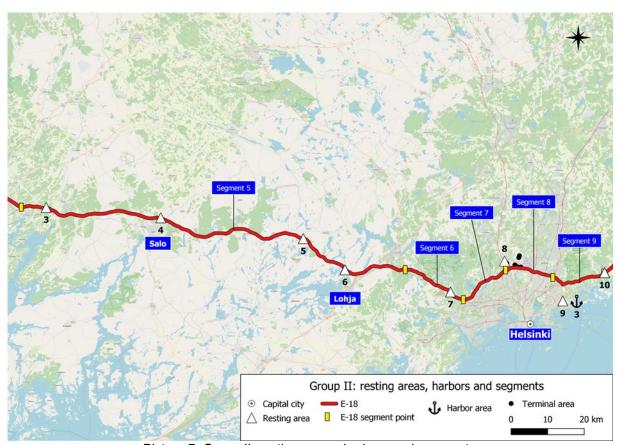
Picture 7. Group II, resting areas, harbors and segments.

Segment 5. Traffic is smooth, there was little traffic. Upgrading speed limits and warnings, height limits under bridges. Calm traffic. Old-fashioned snippet and lots of bends. Outer traces a lot.

Segment 6. At the beginning, a three-lane motor traffic road, becomes two-lane. Good and clear road, clear signage.

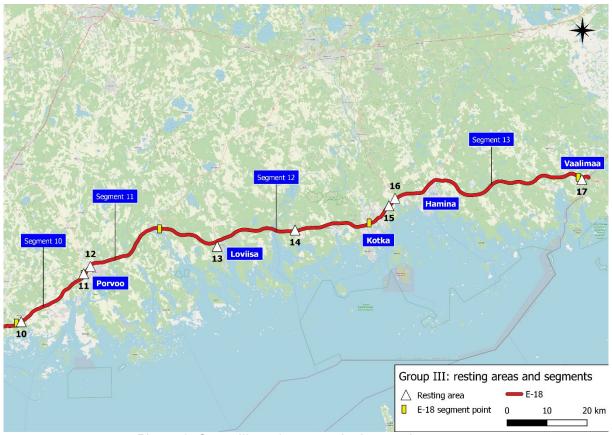
Picture 8. Group III, resting areas, harbors and segments.

Segment 10. There was some commuter traffic near Porvoo, but towards the end of the segment near the Koskenkylä exit, there was almost no other traffic. Our speed remained at 80km/h and there were no incidents on the way that should have been reacted to, for example, by slowing down or braking. The motorway was in a good condition, though basic improvements would be worth making.

Segment 11. Traffic very little, road condition ok, though not perfect. The road coating was worn. But Scania was able to bang the speed allowed by the restrictions.

Segment 12. Traffic fluency very good due to the low volume of traffic. In some places road need new coating. Road markings good. A few professional drivers in traffic and occasional passenger cars. Traffic signage clear and in good condition. Speed steady at 82 km/h, though once we slowed down and gave way as a heavy vehicle joined the road.
